PRESERVATION TREATMENT GUIDE FOR AMK RANCH (UW-NPS RESEARCH CENTER)

MARY M. HUMSTONE ✦ UNIVERSITY OF WYOMING ✦ LARAMIE

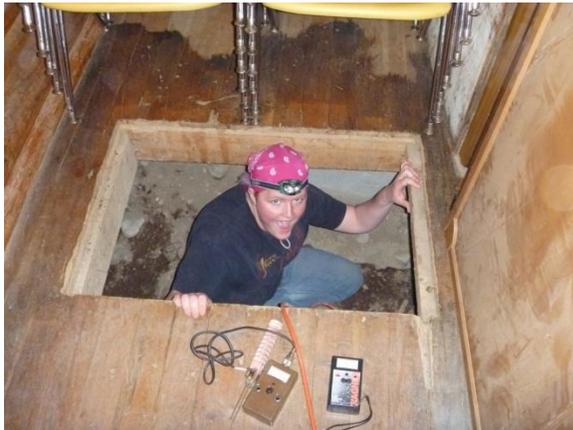
Figure 2. Student Cassie Loveland emerges after conducting moisture-level tests underneath the Berol Lodge at AMK Ranch. (Mary Humstone, 2011).

While most of the building assessments were based on visual inspection, the team also conducted moisture-level testing in crawl spaces below buildings, checked logs for interior rot, and checked for lead paint on surfaces such as window sills (Figure 2). The team took documentary photographs of each building and structure noting both character-defining features and areas of deterioration.

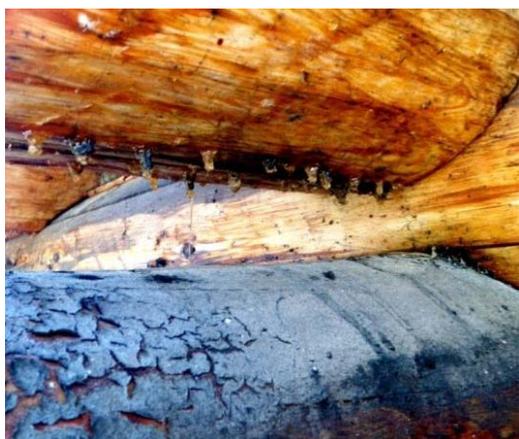
Figure 4. Black fungus growth on logs as a result of treatment with linseed oil. (Mary Humstone, 2011)

One area of particular concern to Research Center director Hank Harlow and caretaker Rich Viola was the black fungus that was growing on the building logs. The research team determined that, due to the application of a preservative made up of linseed oil, turpentine, and paraffin every few years, the log buildings at the AMK Ranch were generally

in good condition, especially compared with other log buildings in the park that have been painted, whitewashed, treated with other finishes or left untreated. However, while the linseed oil protects the logs, it acts as a food source for fungal growth which in turn causes the logs to darken (Figure 4). Additionally, linseed oil breaks down in ultraviolet (UV) light and flakes off, leaving logs unprotected. Because of these negative factors, it was determined this treatment should be discontinued, and replaced with application of borate (a natural log preservative, fungicide, and insecticide) and a UV-blocking preservative.

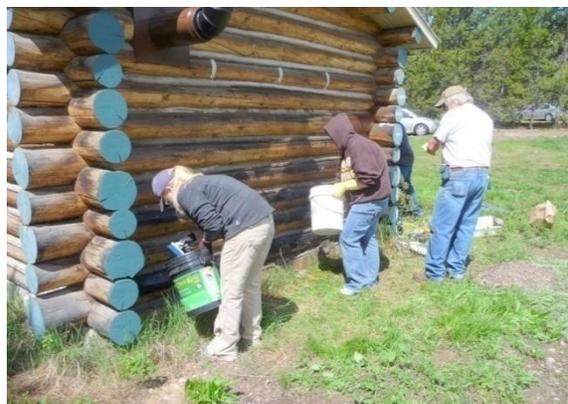
Figure 5. Team members prepare a log wall for testing to compare the effects of different log cleaning techniques. (Mary Humstone, 2011)

Unfortunately, the layers of linseed oil must be removed for the necessary treatments of borate and UV blocker to be effective. The team conducted a series of log-cleaning tests, using different products and different methods of abrasion (Figures 5 and 6). Care was taken to choose cleaning solutions that are non-toxic, such as vinegar, baking soda and biodegradable detergents.

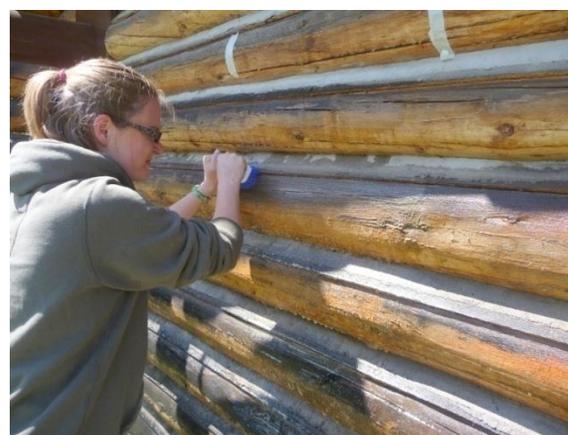
Figure 6. UW student Andrea Lewis cleans logs with abrasive brush after applying a cleaning solution. (Mary Humstone, 2011)

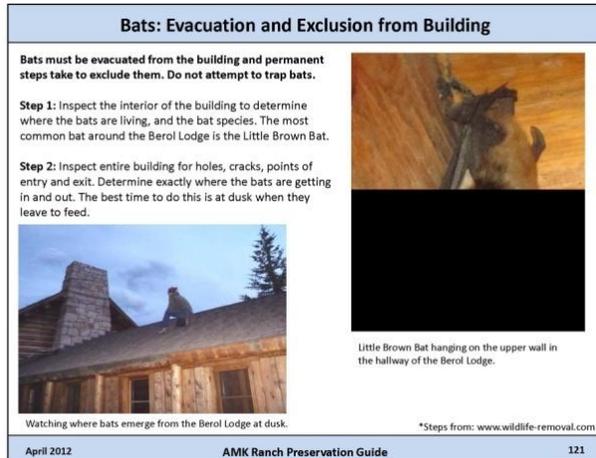
Figure 7. Page from *Preservation Treatment Guide* with step-by-step instructions for bat exclusion. (2011)

Careful inspection of the Berol Lodge revealed the places where bats were entering and exiting the building. The team noted that the existing bat netting around the chimney had been improperly installed and therefore was ineffective. The team studied what methods of bat exclusion had been tried in the past and failed, and researched and analyzed alternative methods for excluding bats in order to come up with a recommended procedure for the AMK Ranch (Figure 7).

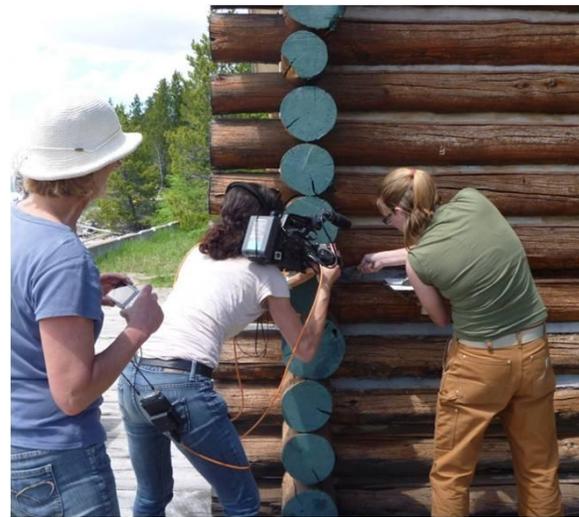
Figure 9. Documentation of log daubing at the AMK Ranch boat house. (Mary Humstone, 2011)

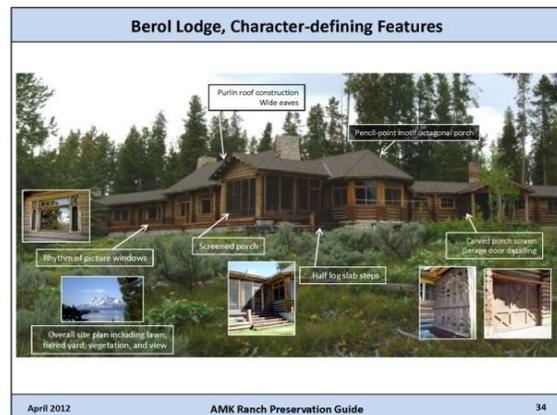
Figure 10. Page from *Preservation Treatment Guide* showing character-defining features of the exterior of the Berol Lodge.

Chapter 2, *Historic Buildings at the AMK Ranch*, contains an illustrated list of the character-defining features of each of the eighteen historic buildings and structures in the AMK Ranch Historic District, and an analysis of maintenance and repair problems and recommended solutions for each property (Figure 10). This section was designed to be used by property managers to create building-by-building files to document and monitor building conditions and treatments.

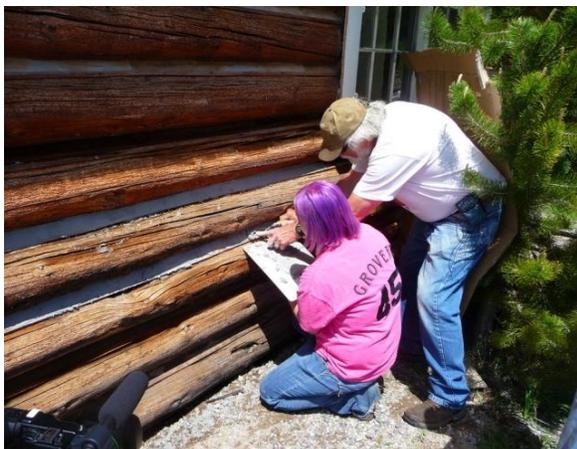
Figure 11. Harrison Goodall shows student Cassie Loveland how to apply daubing to the logs of the boathouse at AMK Ranch. (Mary Humstone, 2011)

Recommendations address issues such as exterior log maintenance, including cleaning, finish, daubing, replacing sill logs, splicing and repairing log crowns and faces (Figure 11); repairing roofs and chimneys; correcting faulty ventilation, flashing, grading and drainage; removing vegetation around buildings; maintaining and repairing windows and doors; snow removal and winterization; and controlling pests, including ants and bats. Specific problems relating to drainage around the Berol Lodge and repair of the southwest porch of the Berol Lodge are included in this chapter (Figure 12).

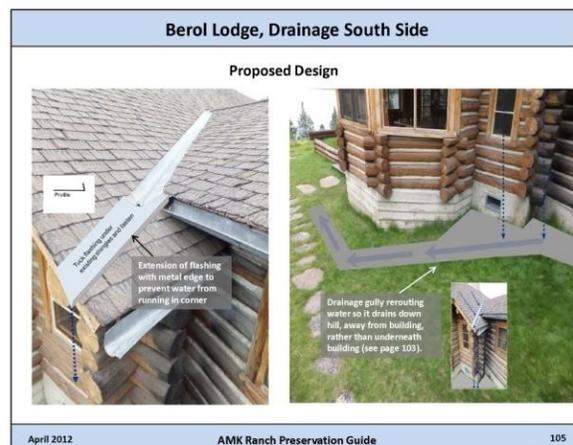
Figure 12. Page from *Preservation Treatment Guide* with step-by-step instructions for improving drainage at the Berol lodge. (2011)
