IN SITU PERFORMANCE ASSESSMENT AND EVALUATION OF HYDROPHOBIC AND ULTRAVIOLET PROTECTIVE TREATMENTS FOR HISTORIC LOG STRUCTURES

COURTNEY L. MAGILL ♦ FRANK G. MATERO
UNIVERSITY OF PENNSYLVANIA ♦ PHILADELPHIA, PA

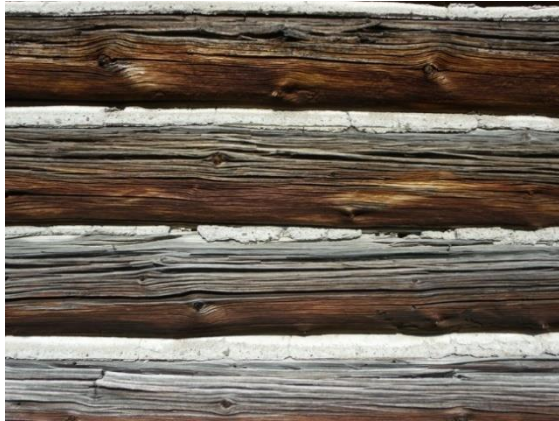
Figure 3. Extant Logs found at the Bar BC Dude Ranch displaying a range of coloration due to lignin loss. Photograph by Christine Leggio for the Bar BC Condition Assessment and Report, 2011 by the Architectural Conservation Laboratory.

Many historic log structures in the American West are exposed to a large amount of UV radiation due to their base elevation. In addition to problems delineated from contact with water, the wood itself is damaged by UV light through degradation of lignin, the component of wood that holds cellulose fibers together (Figure 3). Exposed wooden members are often affected in a matter of days. Small depth of penetration restricts damage to surface area; however, when combined with shrinkage and swelling of water

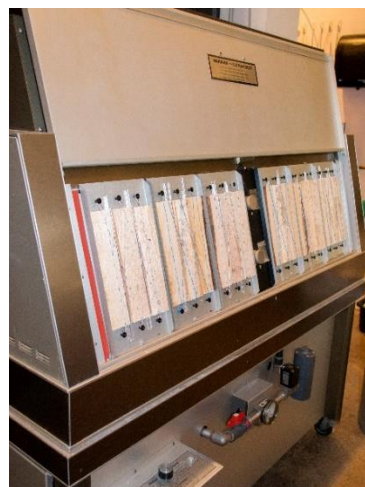
Figure 4. The QUV Weatherometer used for accelerated weathering in the Architectural Conservation Laboratory at the University of Pennsylvania. Photograph by the author.

Accelerated weathering testing was conducted for 800 total hours in the spring of 2015 using a QUV Weatherometer at the ACL (Figure 4), which simulates weathering by subjecting samples to cycles of UV-B light, heat, condensation, and sprayed water. While artificial weathering occurs in more intense, concentrated cycles than those in nature, results can be a good indicator of longer-term performance of the treatments. In this preliminary testing, treatments were tested on samples of sapwood of Idaho-sourced lodgepole pine (*Pinus contorta latifolia*), a common building material in the Greater Yellowstone Region, obtained from Wilmore Lumber Ltd., a supplier in the area. Samples were monitored

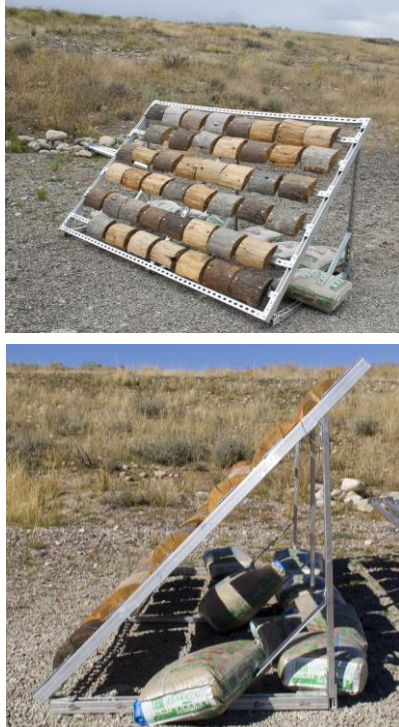
Figure 5. Erected weathering bracket viewed at an angle (above) and from the side (below). Photos by the author.

Eight 8-foot lengths of aluminum strut channel were fastened to 5-foot lengths of strut with zinc-plated steel brackets and high-strength steel cap screws to create a rectangular bracket. This design allows for six rows of samples to be bolted in place on the struts. This rectangular bracket was then inclined by bolting it to 3-foot lengths of strut at both ends and in the center; these were in turn connected and braced to another 8-foot length of strut for stabilization of the setup. Sandbags were laid on the base struts to anchor the bracket in place (Figure 5).

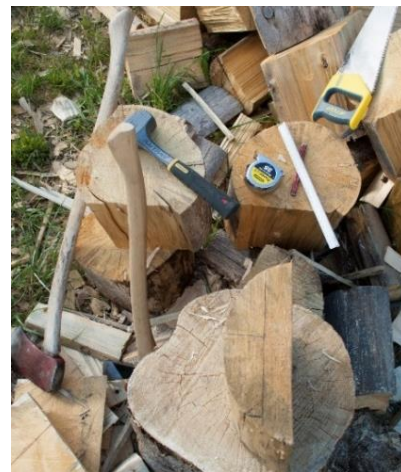
Figure 6. Samples were prepared by cutting off tangential sections of both new and weathered logs onsite at the White Grass Dude Ranch. Photograph by the author.

Log samples for each treatment were prepared according to standard D7787-D7787M – 13 Standard Practice for Selecting Wood Substrates for Weathering Evaluations of Architectural Coatings (ASTM 2011). To observe how these coatings behave on weathered material as well as new wood, sample panels were cut from both newly felled and older logs (Figure 6). Weathered panels were cut from logs salvaged from naturally fallen lodgepole pine sourced on the property of the White Grass Dude Ranch. New panels were created from newly cut, but seasoned, logs of lodgepole pine also from material at White Grass. These logs were sourced by the Western Center for Historic Preservation for use on onsite repairs and replacements. Both new and old log samples were stripped of any remaining bark using a draw knife. The panels were cut tangentially from the outer edges of the chosen logs to give a curved, convex surface to better imitate architectural logs in situ.

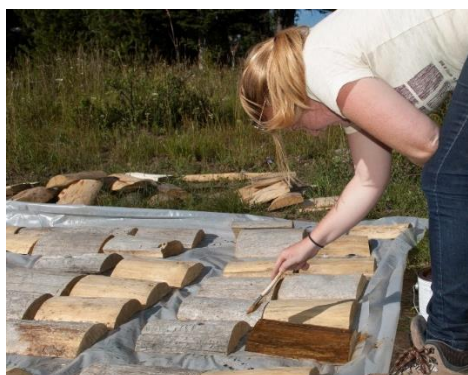
Figure 7. Application of stains to cohorts of samples. Photograph by the author.

Treatments were applied to the panels (Figure 7) according to each manufacturer's instructions. They were applied to the face of the panel with brushes, but not on the end grain or the back to imitate treatment application of stains in the field on architectural logs. Once the treatments properly dried, the end grain of the panels was sealed by dipping each end in satin-finish polyurethane and allowing it to cure.

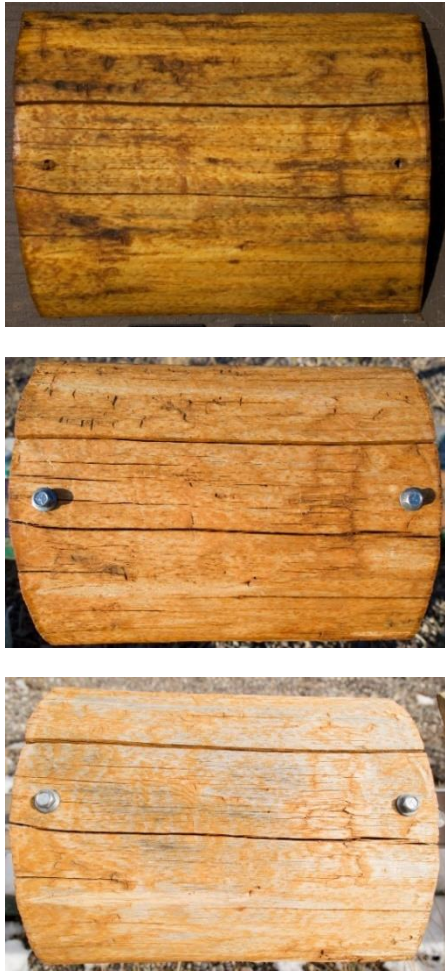
Figure 9. Progression of new wood sample N-TWP-2 showing before weathering (top), at one year (middle) and at two years (bottom). Photographs by the author.

All samples, both new and old, significantly lightened over the two-year test period and most approached a similar grey and weathered appearance to that of the control panels. The most striking treatment shifts over the two years occurred on the panels treated with TWP (Figure 9). While these panels had a red hue to begin with, the finish became quite orange after one year and irregularly spotted and streaked with grey and orange patches by year two,

especially on the new wood panels. The Messmer's product also appeared mottled upon inspection at two years, on the new wood for the most part, but was less striking visually because the treatment appeared more brown. The mottled appearance of TWP and Messmer's indicates that both treatments were likely not absorbed as well by the new wood panels and created more film-like coatings.

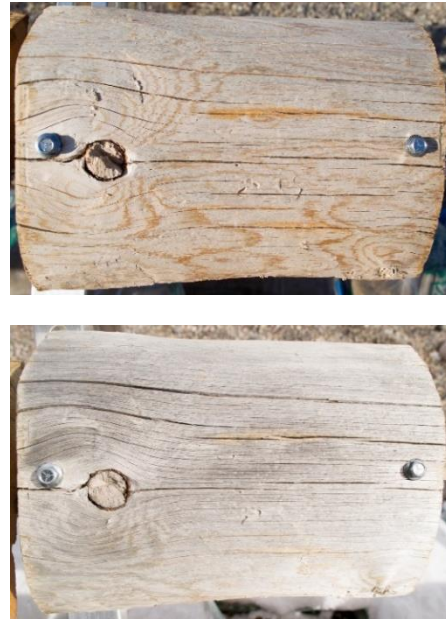
Figure 10. DEFY new wood sample N-DEF-3 at one year (above) and two years (below). Photographs by the author.

The DEFY-treated panels are significantly lighter than the other panels, especially the new wood panels. After one year, these new wood panels were mostly white with light brown streaks, but after two years have more closely approached the grey color of the controls (Figure 10).

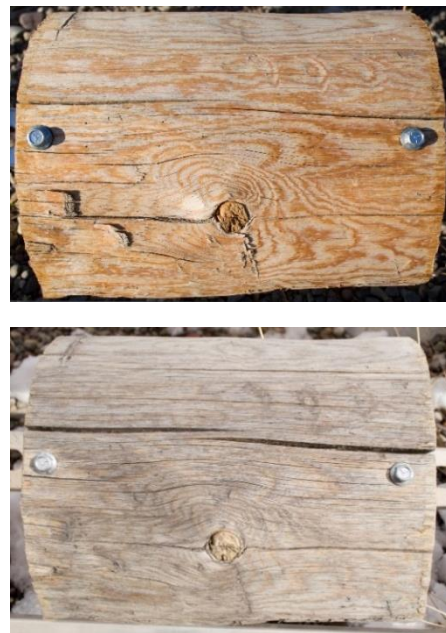
Figure 11. New wood linseed oil panel, N-LIN-3, at one year (above) and two years (below). Photographs by author.

The linseed oil and mixture treatments had similar effects on the coloring and appearance of their panels (Figure 11). On the new wood panels, each treatment enhanced the grain of the early and late wood after one year, likely due to differential penetration of the product in these areas; however, during the second year the wood surfaces also began to approach the same coloring as the controls, both for new and old wood (Figure 12).

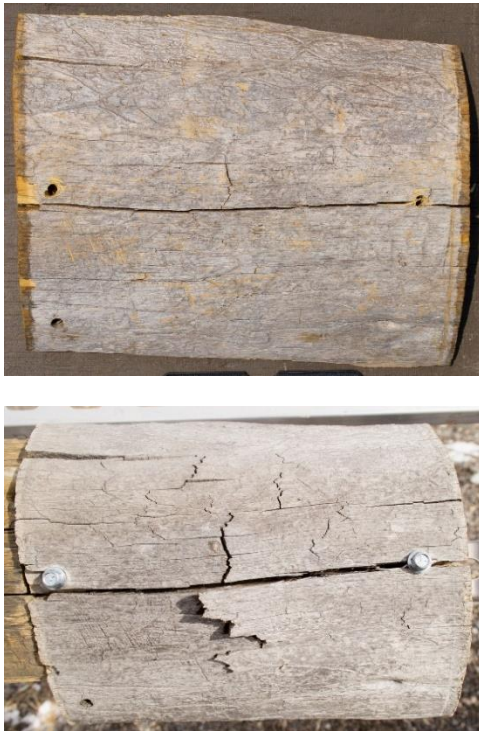
Figure 12. Weathered control panel, W-CON-2, progression from before weathering (above) to two years (below). Photographs by the author.

Many panels, both treated and untreated, experienced macroscopic changes as well such as checking, cracking, and warping in certain cases; these changes were easily noticeable in photographs over time.

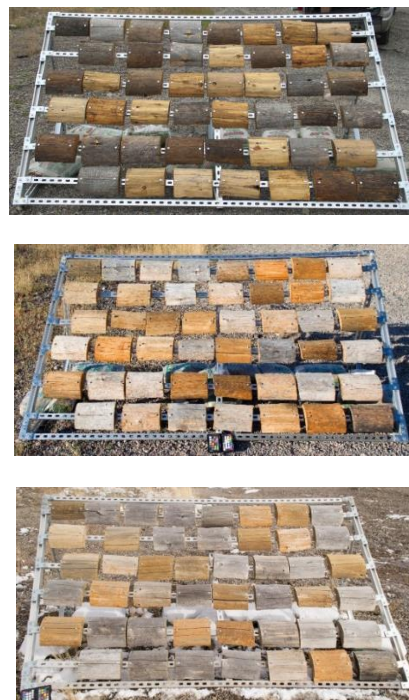
Figure 15. Weathering rack with samples at time of installation in August 2015 (top), at one year (middle), and at two years (bottom). Photographs by the author.

⁶ During the second year of measurements, the panels were coated with snow during the site visit (Figure 15). Attempts were made to dry them out before measurement, but the moisture levels were higher

than previous evaluation and the panels weighed more than the previous year. Therefore, the data was not viable for analysis.
